Appendix A
Revision 1 (April 29, 2011)
to AMOC letter to L115W-11-315
Alternative Inspection Procedure
for
AD 2011-07-13

Affected models: Commander Aircraft Corporation, Gulfstream Aerospace Corporation,
and Rockwell International models 112, 112B, 112TC, 112TCA, 114,
114A, 114B, 114TC.

AD referenced by
this AMOC: 2011-07-13

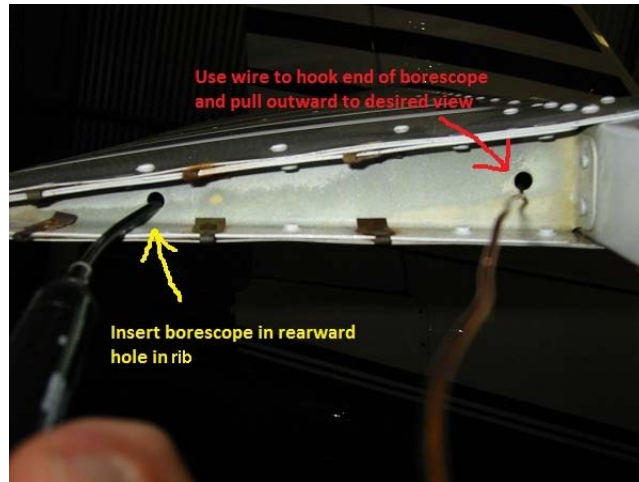
- d. **Full length rib used in most early models.** Insert borescope in the rear lightening hole on the outer elevator rib (see picture below). Inspection should cover the areas surrounding the four attachment nuts and extending upward and downward to the elevator skins and at least 1" inboard and outboard from the nuts. If suspect areas are noted, proceed to Step 4.

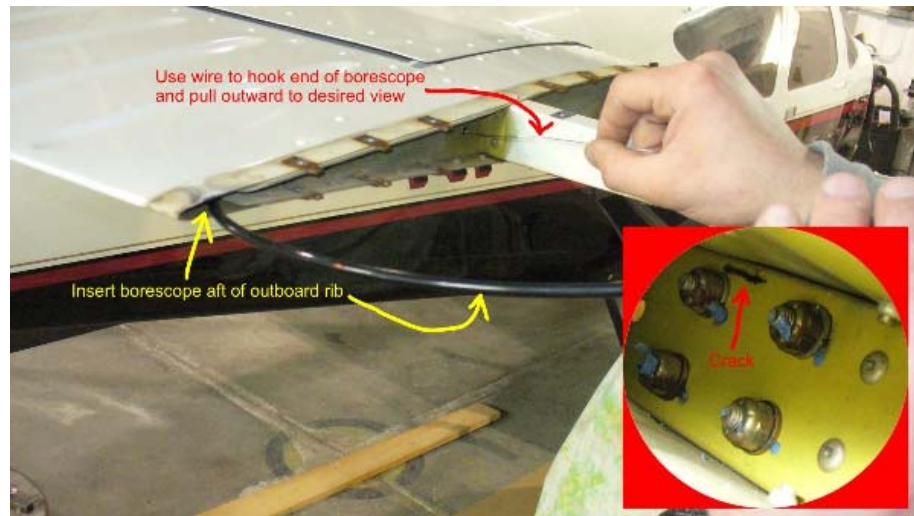
- e. **Shortened rib used in most later models.** Insert the borescope between the aft end of the outboard elevator rib and the trailing edge of the elevator skin (see picture below).

Inspection should cover the areas surrounding the four attachment nuts and extending upward and downward to the elevator skins and at least 1" inboard and outboard from the nuts. If suspect areas are noted, proceed to Step 4.
